Paper Type: Original Article

Investigation of Progressive Collapse Occurrence under Main and Aftershocks Earthquake

Armin Karimi*

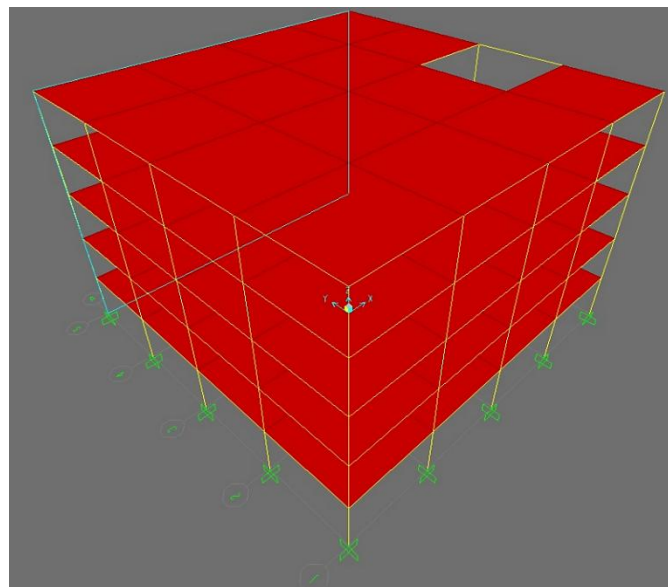
Fig. 1. Example of modelling.

After drawing the geometric model of the desired element of the structure, we must assign the type of materials used and their environmental and physical characteristics. In general, the modelling should be done in such a way that the nodes of the adjacent members match each other. And apply loads to each other so that we can see the node's behaviour at the desired point in case of an element failure. An example of modelling is shown in *Fig. 1*.

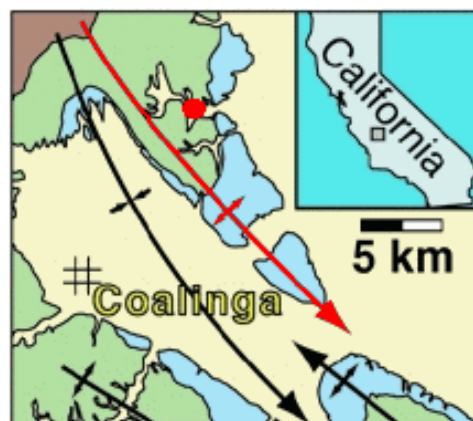
Fig. 2. Coalinga earthquake.

In *Fig. 2*, the red line shows the centre of the Koalinga anticline, and the red dots show the centre of the earthquake. Quaternary slates are pale blue, ternary stones are green, and gypsum stones are brown.

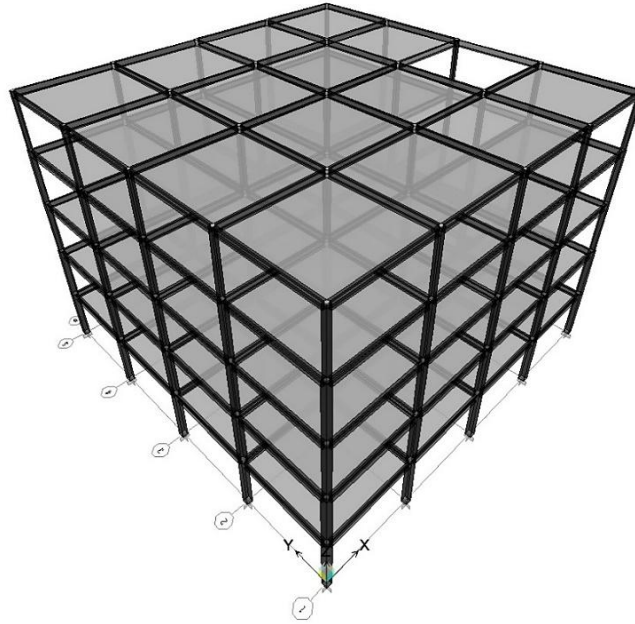
Fig. 3. Modelling of model 1 in ETABS software.

The 3D structural model for model 1 representation in ETABS software that shown in *Fig. 3* also you can see the stress percentage in the designed sections of model 1 in *Figs. 4-8*.

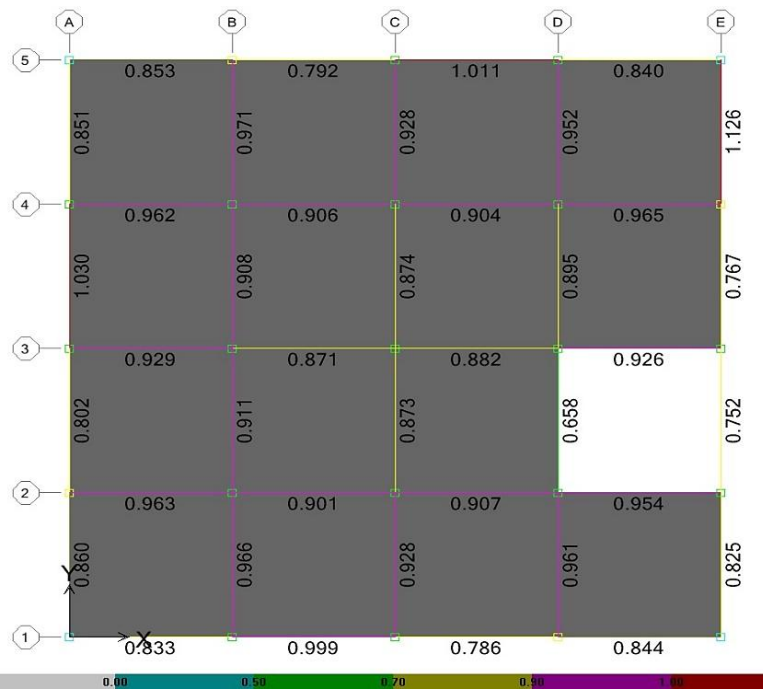
Fig. 4. The stress percentage in the designed sections of model 1 in ETABS software.

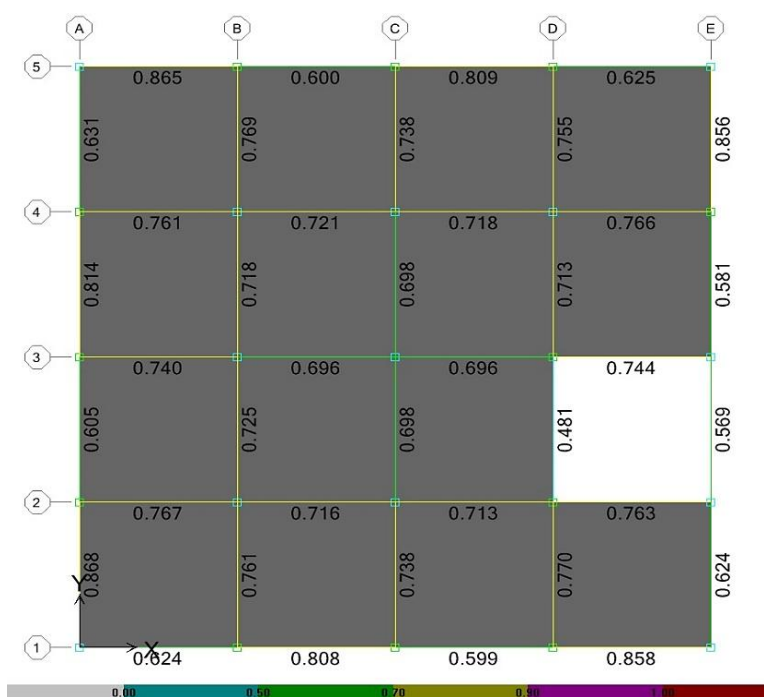
Fig. 5. The stress percentage in the designed sections of Model 1 in ETABS software.

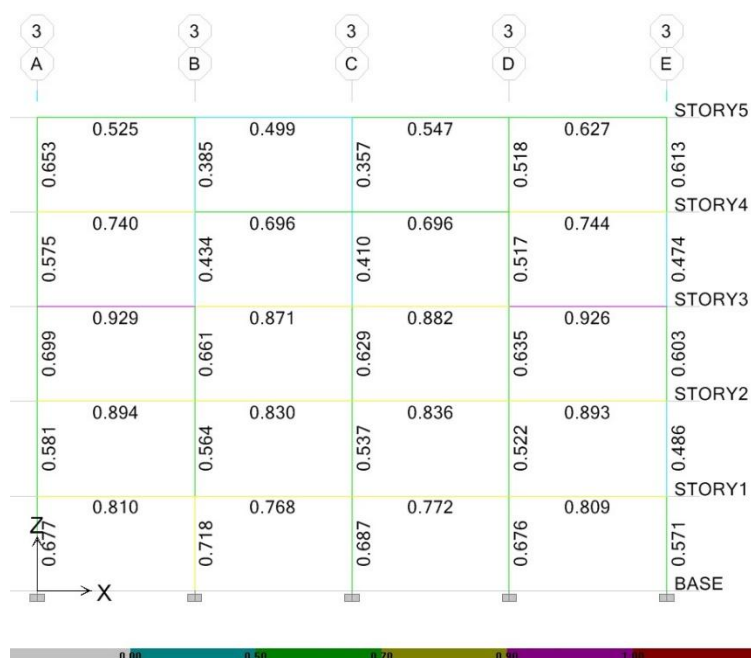
Fig. 6. The stress percentage in the designed sections of Model 1 in ETABS software.

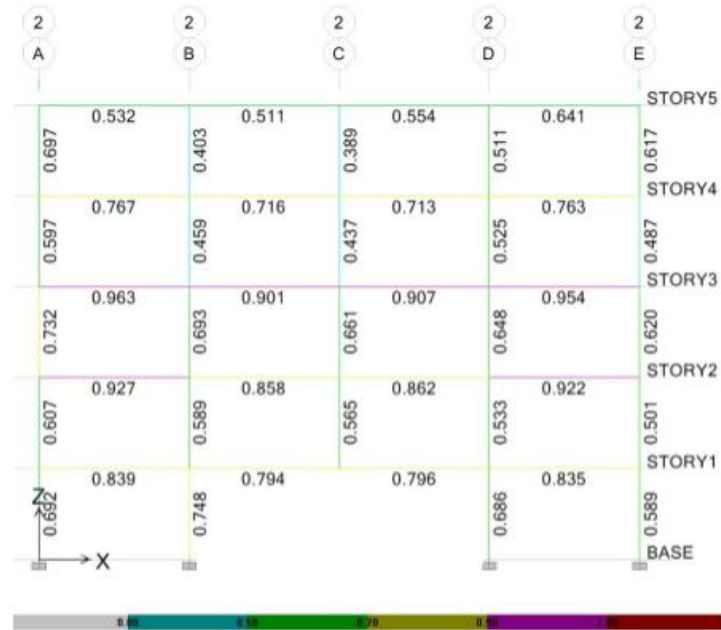
Fig. 7. The percentage of stress in the designed sections of Model 1 in ETABS software and with progressive failure.

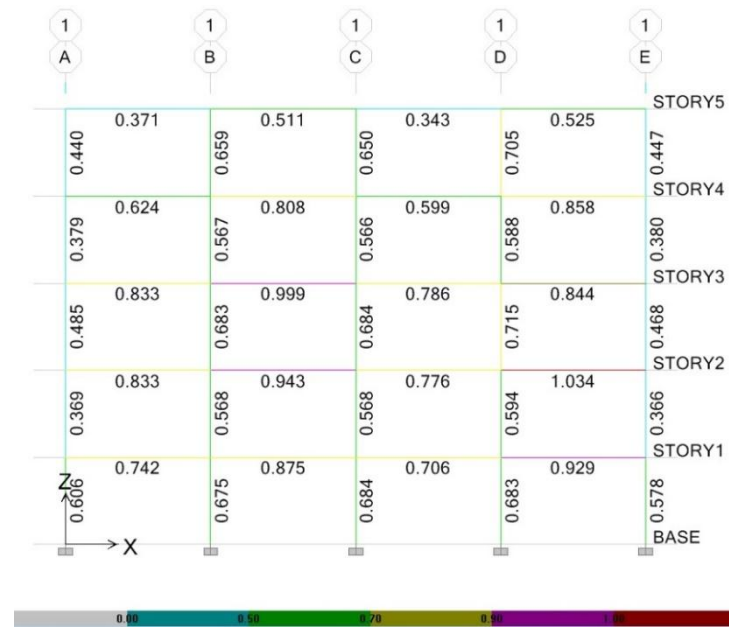
Fig. 8. The stress percentage in the designed sections of Model 1 in ETABS software.

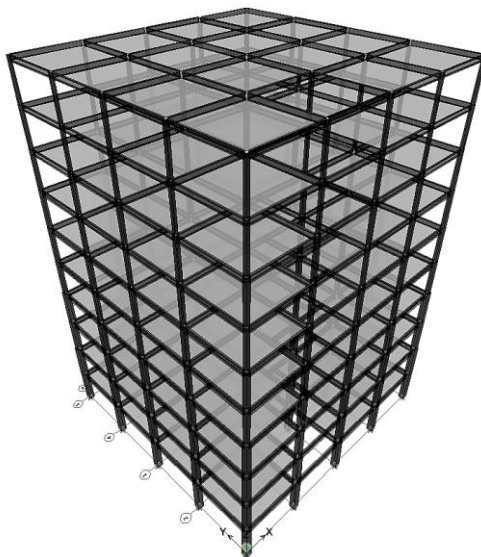
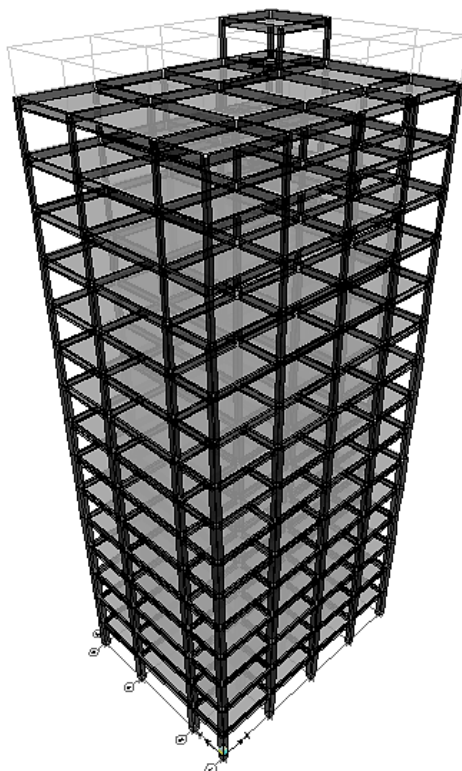
Fig. 9 and *Fig. 10* illustrate the three-dimensional models developed for this study using ETABS software. The models represent two different structural configurations that were analyzed to evaluate their response to progressive collapse under various load conditions. Both models were designed to replicate the realistic structural behavior of multi-story buildings under seismic and other dynamic loads. The accurate modeling of such systems enables a detailed investigation into the resilience of the structures and the potential failure mechanisms. These models form the basis for nonlinear static and dynamic analyses, aiding in understanding how different failure scenarios can unfold in practical engineering environments.

Fig. 9. Modeling Model 2 in ETABS software.

Fig. 10. Modeling Model 2 in ETABS software.

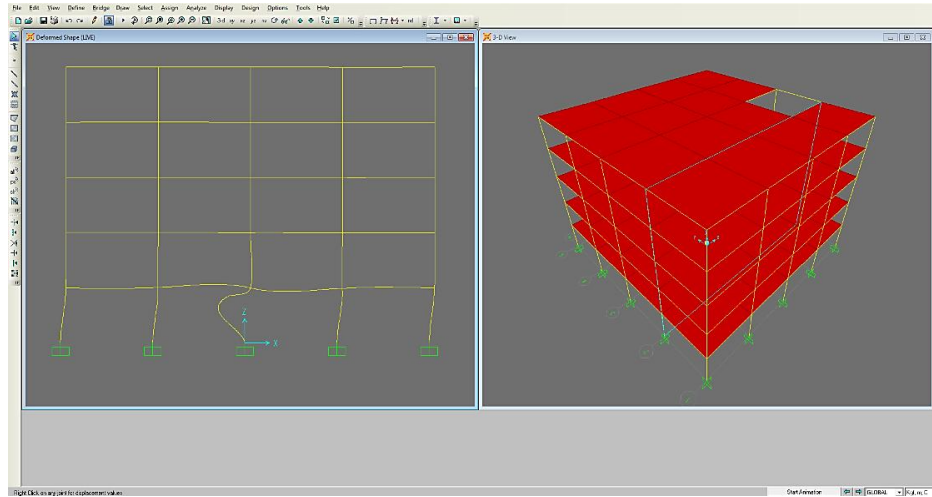
Fig. 11. Column damage in a 5-story structure.

This study employs the AP method, which operates independently of the failure criteria suggested by GSA and DoD, alongside nonlinear dynamic analysis. Two different column removal scenarios were considered. Since the AP method is not dependent on specific failure factors, two large, opposing concentrated loads (Exceeding the column's capacity) are instantaneously applied to a ground floor column, resulting in its shear failure and subsequent collapse.

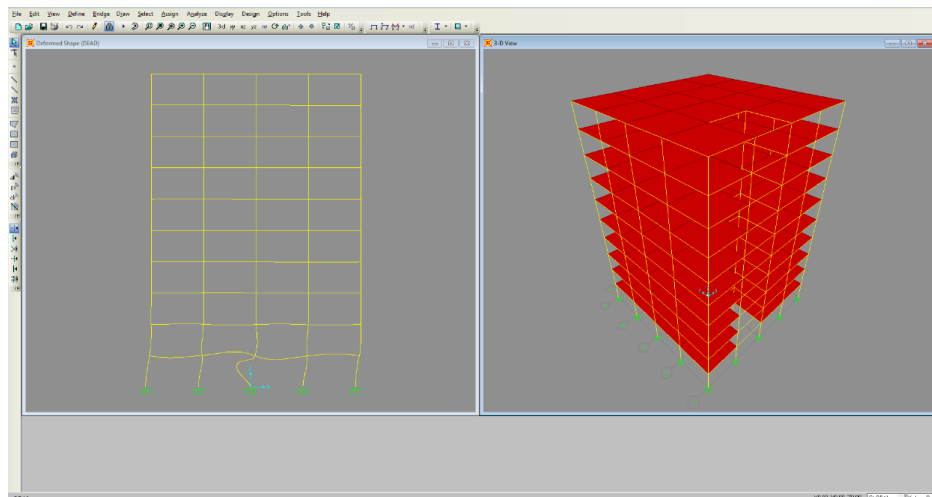
Fig. 12. Column damage in a 10-story structure.

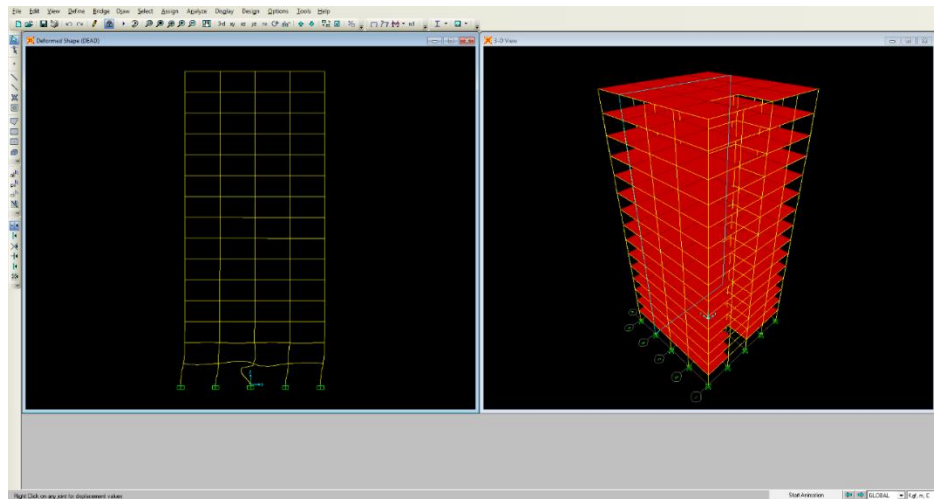
Fig. 13. Column failure in a 15-story structure.

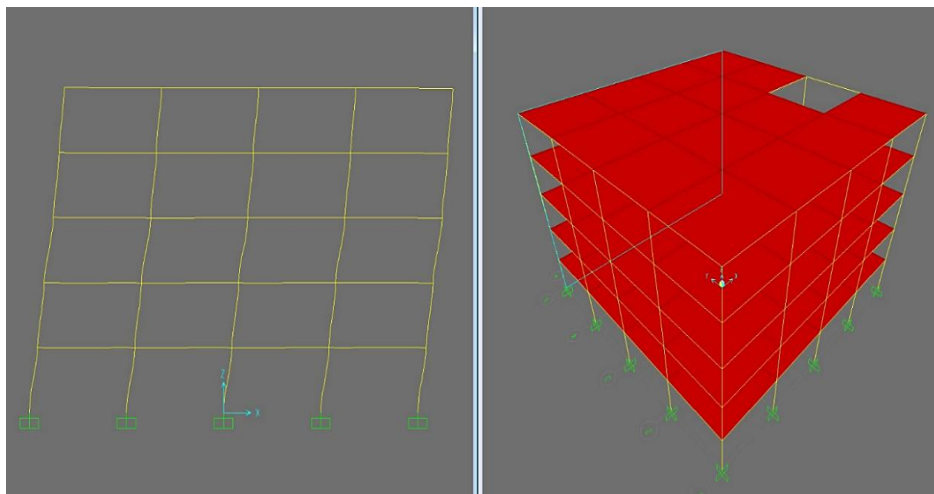
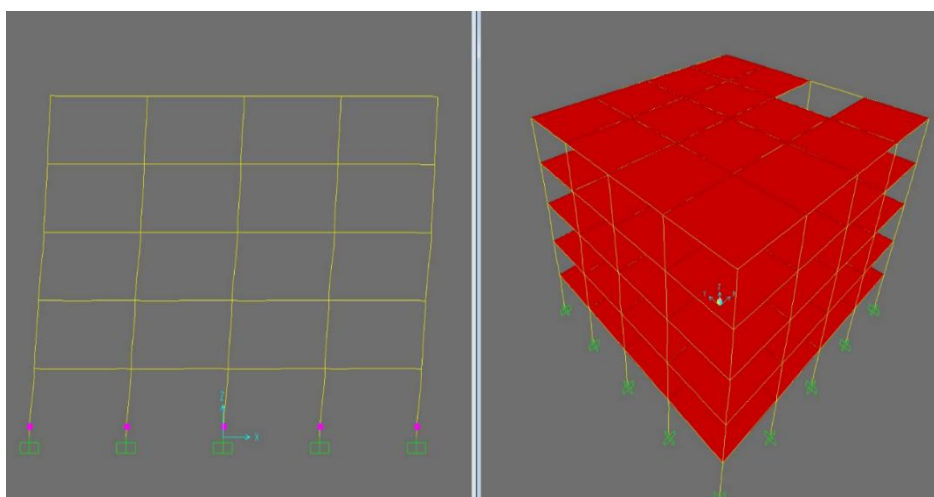
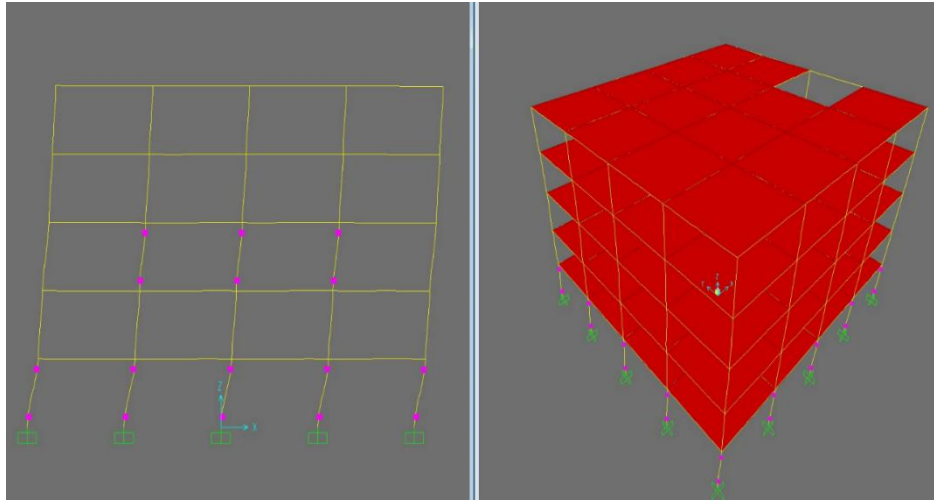
Fig. 14. The mechanism of forming plastic joints Model 1 in SAP software.

Fig. 15. The mechanism of forming plastic joints Model 1 in SAP software.

Fig. 16. Mechanism of forming plastic joints Model 1 in SAP software.

According to the mechanism of rupture and deformation of structures with progressive failure under investigation, we see the proper and regular operation of the system in such a way that at the point of destruction of the structure, plastic joints are formed in more than 60% of the members, and this is a sign of the proper design of the system. We also see the structure's performance in the area of life safety.
