## Investigation of Progressive Collapse Occurrence under Main and Aftershocks Earthquake

Karimi, A. (2024). Investigation of progressive collapse occurrence under main and aftershocks earthquake. *Journal of civil aspects and structural engineering*, 1 (1), 39-53.

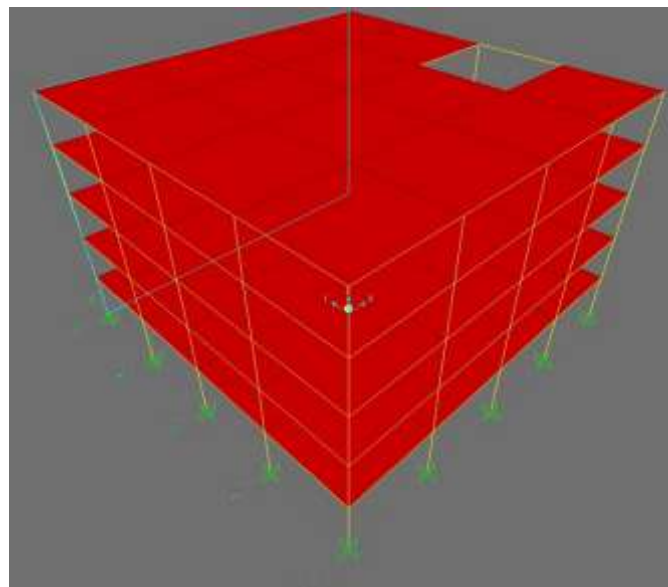
**Fig. 1. Example of modelling.**

After drawing the geometric model of the desired element of the structure, we must assign the type of materials used and their environmental and physical characteristics. In general, the modelling should be done in such a way that the nodes of the adjacent members match each other. And apply loads to each other so that we can see the node's behaviour at the desired point in case of an element failure. An example of modelling is shown in *Fig. 1*.

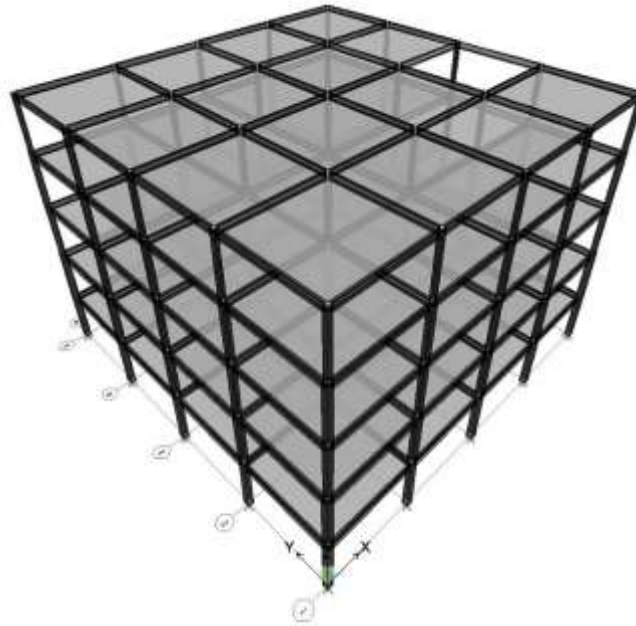
Fig. 3. Modelling of model 1 in ETABS software.

The 3D structural model for model 1 representation in ETABS software that shown in *Fig. 3* also you can see the stress percentage in the designed sections of model 1 in *Figs. 4-8*.

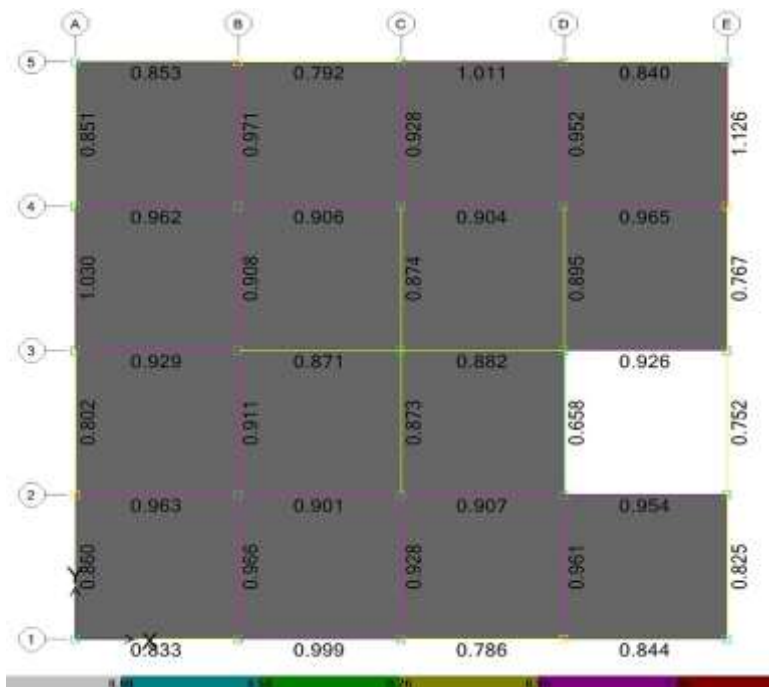
Fig. 4. The stress percentage in the designed sections of model 1 in ETABS software.

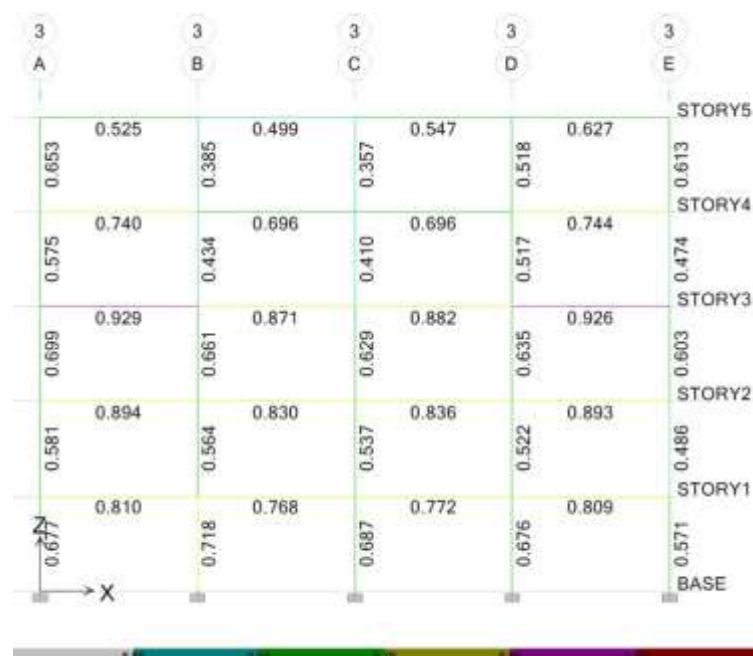
Fig. 6. The stress percentage in the designed sections of Model 1 in ETABS software.

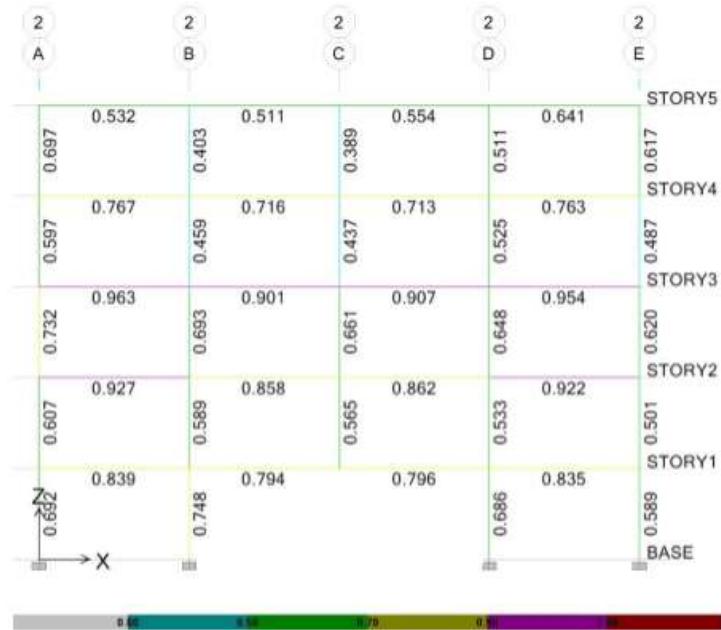
Fig. 7. The percentage of stress in the designed sections of Model 1 in ETABS software and with progressive failure.

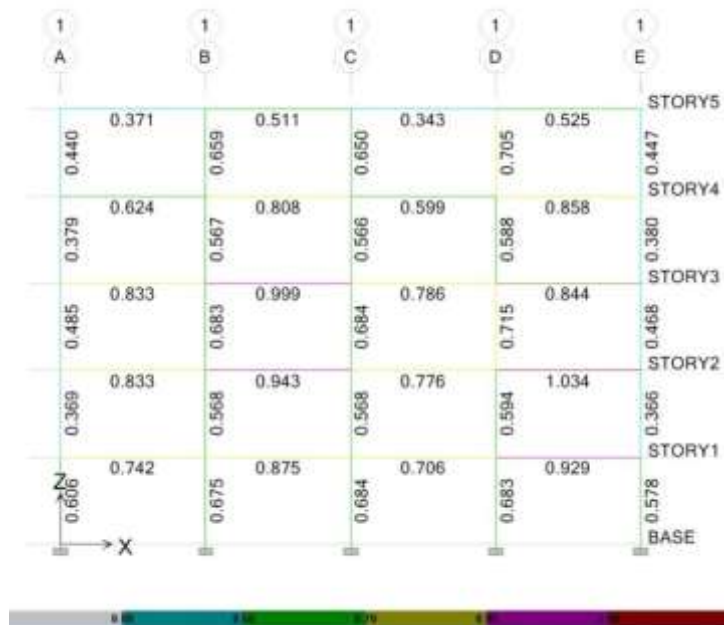
Fig. 8. The stress percentage in the designed sections of Model 1 in ETABS software.

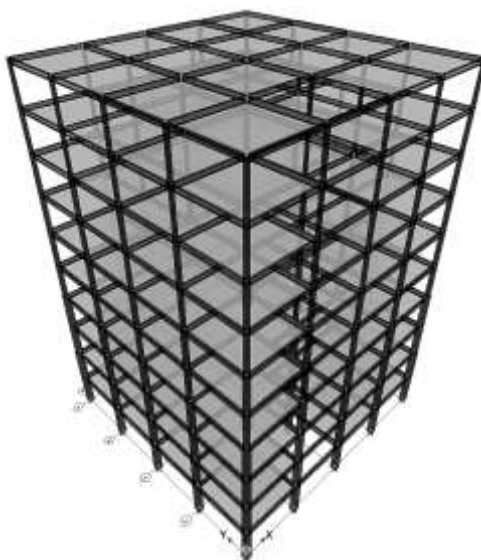
**Fig. 9. Modeling Model 2 in ETABS software.**

*Fig. 9* and *Fig. 10* illustrate the three-dimensional models developed for this study using ETABS software. The models represent two different structural configurations that were analyzed to evaluate their response to progressive collapse under various load conditions. Both models were designed to replicate the realistic structural behavior of multi-story buildings under seismic and other dynamic loads. The accurate modeling of such systems enables a detailed investigation into the resilience of the structures and the potential failure mechanisms. These models form the basis for nonlinear static and dynamic analyses, aiding in understanding how different failure scenarios can unfold in practical engineering environments.

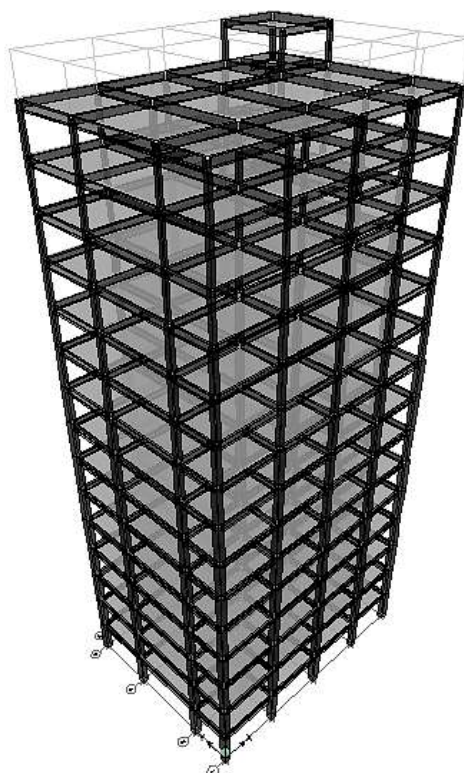
**Fig. 10. Modeling Model 2 in ETABS software.**

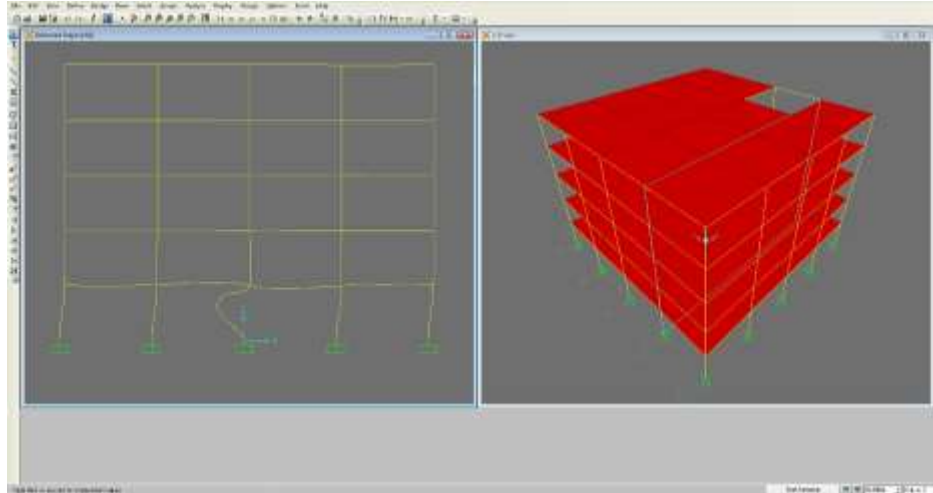
Fig. 11. Column damage in a 5-story structure.

This study employs the AP method, which operates independently of the failure criteria suggested by GSA and DoD, alongside nonlinear dynamic analysis. Two different column removal scenarios were considered. Since the AP method is not dependent on specific failure factors, two large, opposing concentrated loads (Exceeding the column's capacity) are instantaneously applied to a ground floor column, resulting in its shear failure and subsequent collapse.

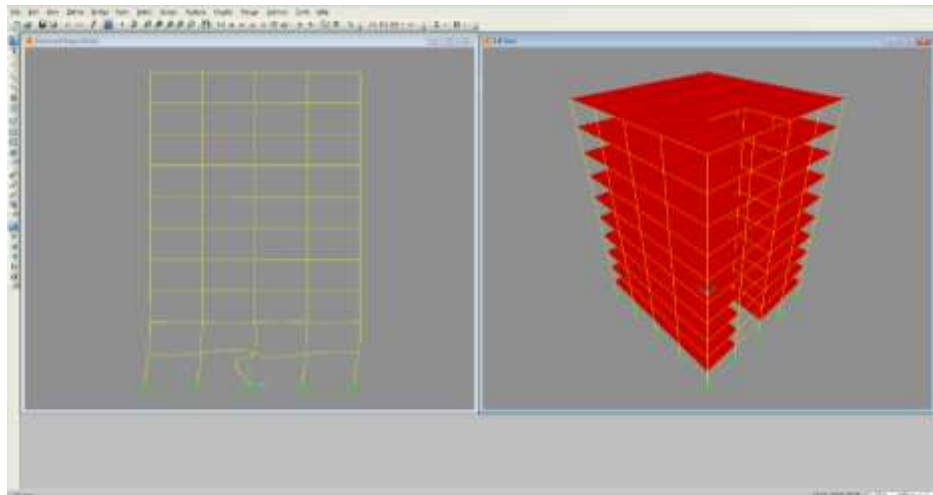
Fig. 12. Column damage in a 10-story structure.

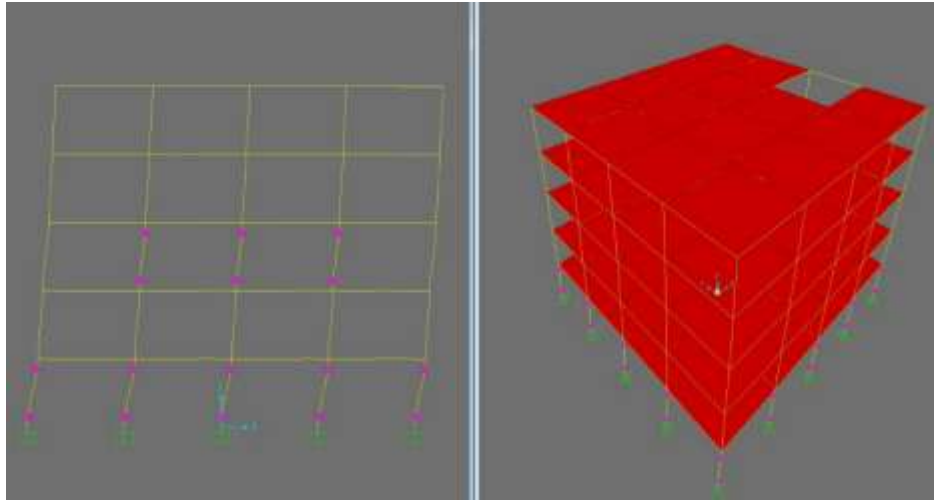
Fig. 16. Mechanism of forming plastic joints Model 1 in SAP software.
