## Investigation of Progressive Collapse Occurrence under Main and Aftershocks Earthquake

Armin Karimi\*

Structural Engineer (MSc), Neptune Technical and Engineering Office, Abbas Abad, Mazandaran Province, Iran;  
eng.arminkarimi723@gmail.com.

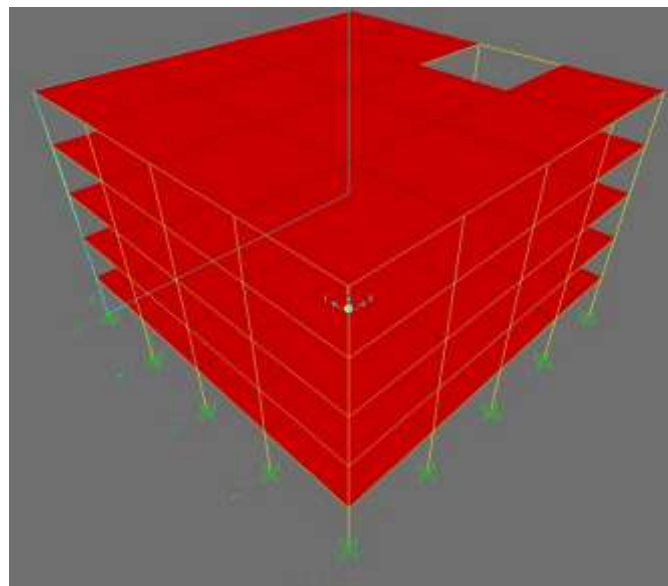
**Fig. 1. Example of modelling.**

After drawing the geometric model of the desired element of the structure, we must assign the type of materials used and their environmental and physical characteristics. In general, the modelling should be done in such a way that the nodes of the adjacent members match each other. And apply loads to each other so that we can see the node's behaviour at the desired point in case of an element failure. An example of modelling is shown in *Fig. 1*.

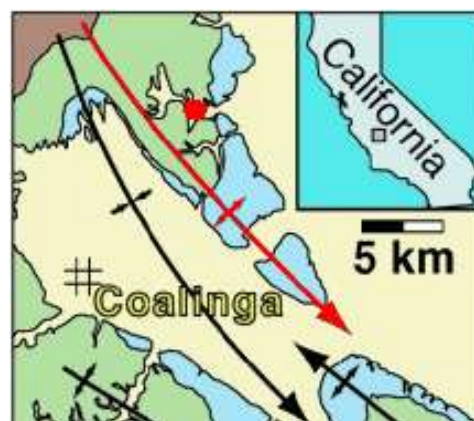
Fig. 2. Coalinga earthquake.

In *Fig. 2*, the red line shows the centre of the Koalinga anticline, and the red dots show the centre of the earthquake. Quaternary slates are pale blue, ternary stones are green, and gypsum stones are brown.

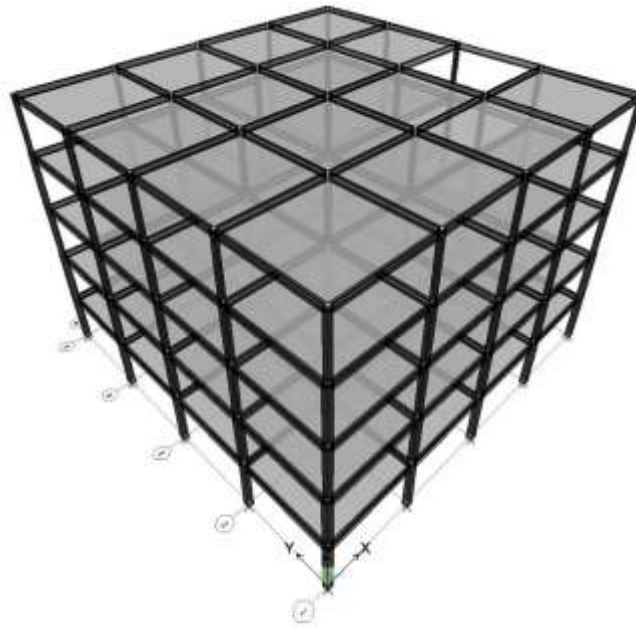
Fig. 3. Modelling of model 1 in ETABS software.

The 3D structural model for model 1 representation in ETABS software that shown in *Fig. 3* also you can see the stress percentage in the designed sections of model 1 in *Figs. 4-8*.

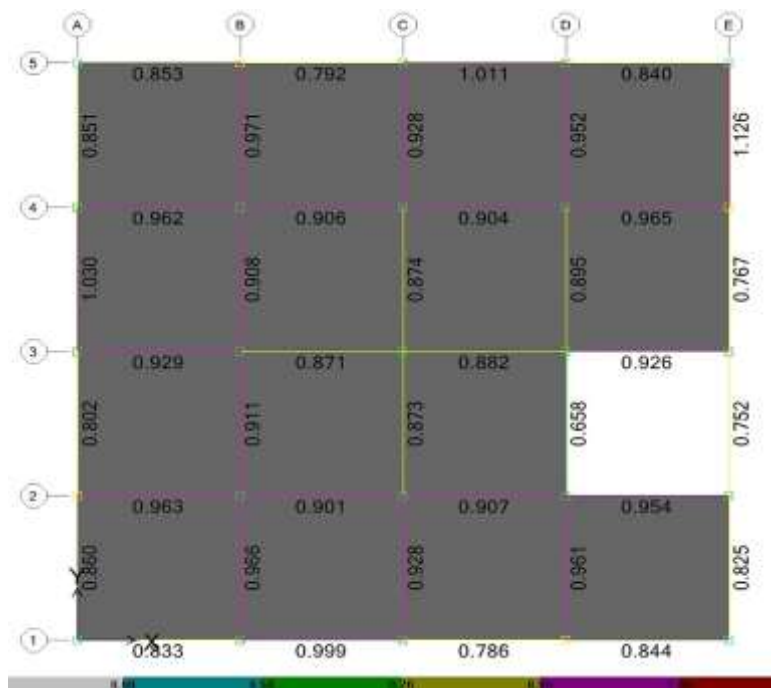
Fig. 4. The stress percentage in the designed sections of model 1 in ETABS software.

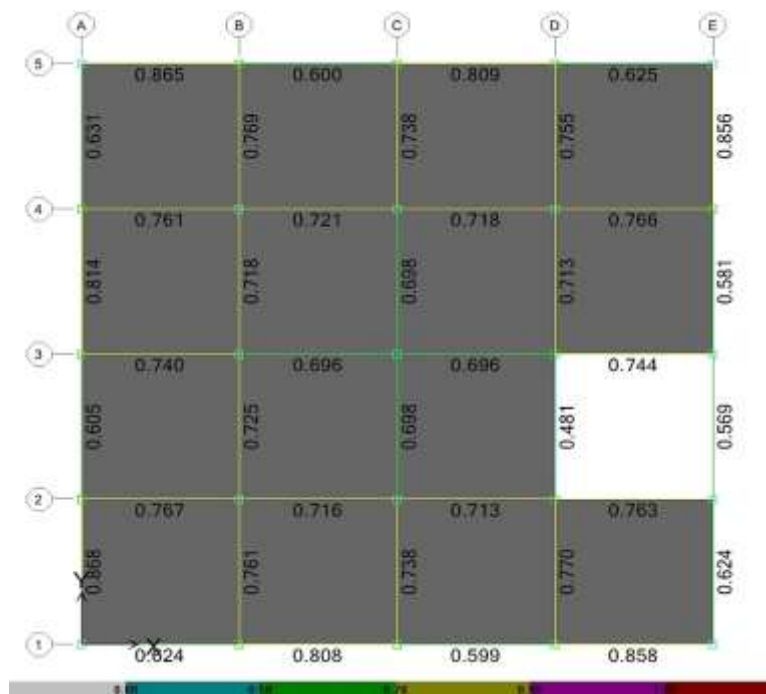
Fig. 5. The stress percentage in the designed sections of Model 1 in ETABS software.

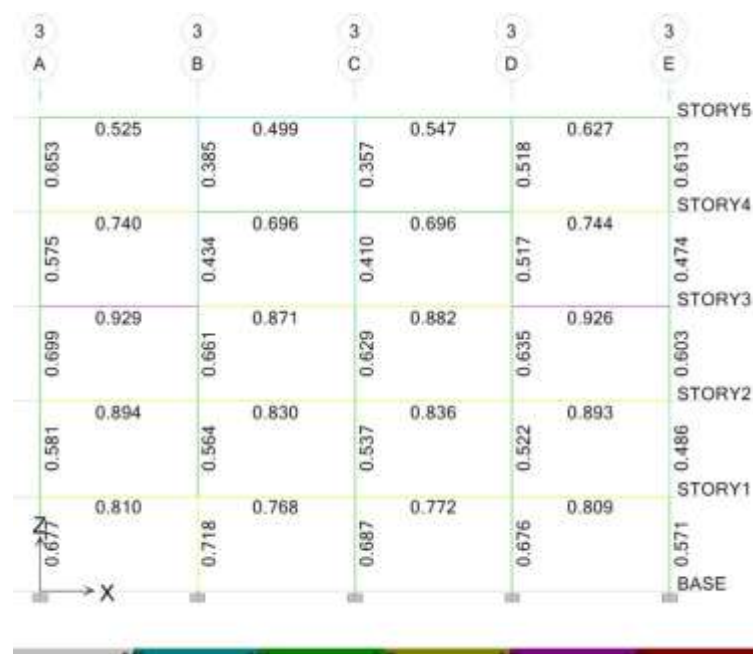
Fig. 6. The stress percentage in the designed sections of Model 1 in ETABS software.

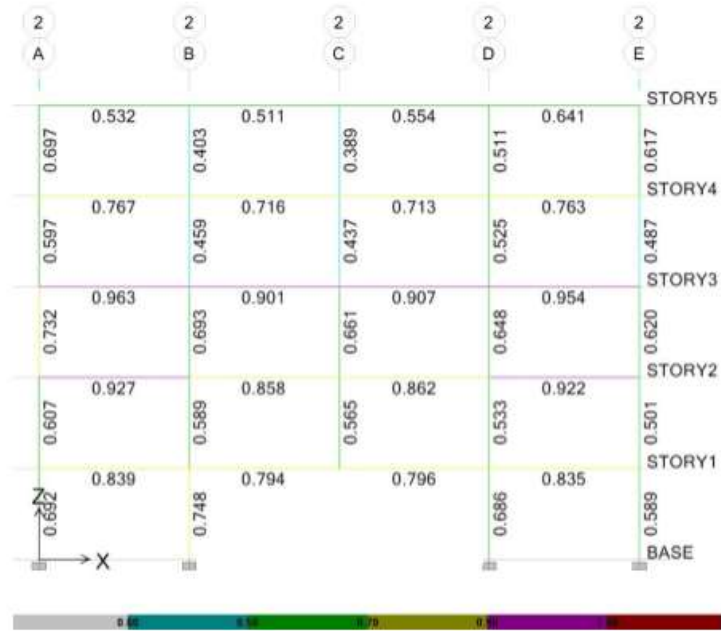
Fig. 7. The percentage of stress in the designed sections of Model 1 in ETABS software and with progressive failure.

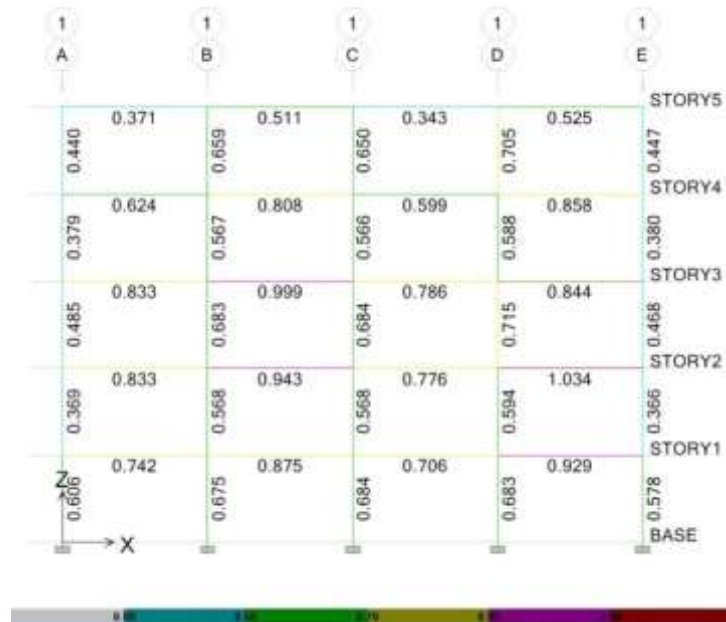
Fig. 8. The stress percentage in the designed sections of Model 1 in ETABS software.

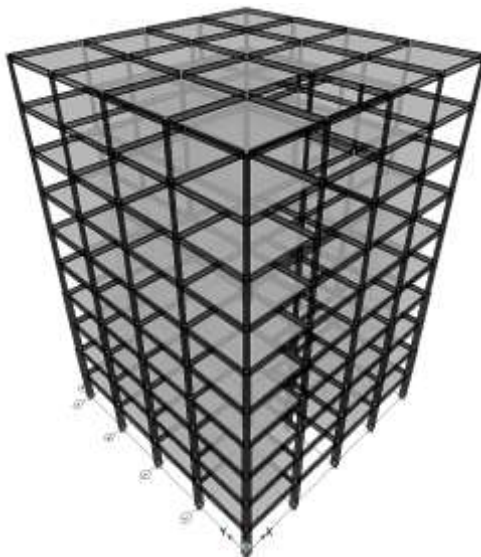
**Fig. 9. Modeling Model 2 in ETABS software.**

*Fig. 9* and *Fig. 10* illustrate the three-dimensional models developed for this study using ETABS software. The models represent two different structural configurations that were analyzed to evaluate their response to progressive collapse under various load conditions. Both models were designed to replicate the realistic structural behavior of multi-story buildings under seismic and other dynamic loads. The accurate modeling of such systems enables a detailed investigation into the resilience of the structures and the potential failure mechanisms. These models form the basis for nonlinear static and dynamic analyses, aiding in understanding how different failure scenarios can unfold in practical engineering environments.

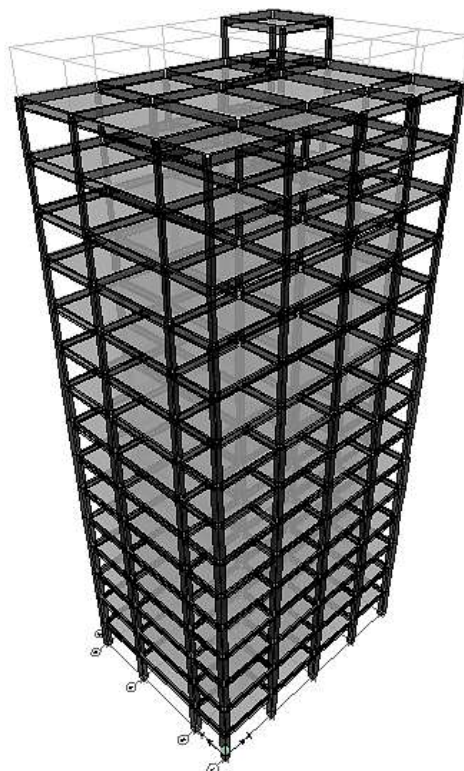
**Fig. 10. Modeling Model 2 in ETABS software.**

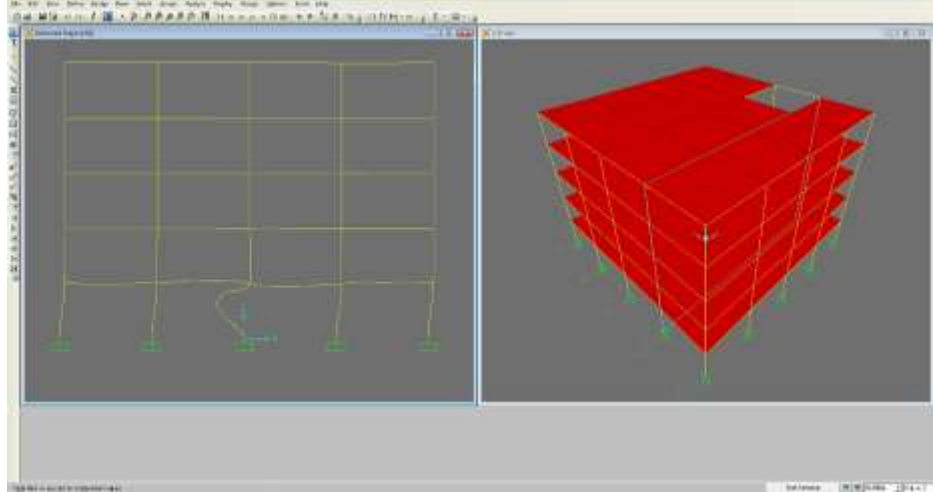
Fig. 11. Column damage in a 5-story structure.

This study employs the AP method, which operates independently of the failure criteria suggested by GSA and DoD, alongside nonlinear dynamic analysis. Two different column removal scenarios were considered. Since the AP method is not dependent on specific failure factors, two large, opposing concentrated loads (Exceeding the column's capacity) are instantaneously applied to a ground floor column, resulting in its shear failure and subsequent collapse.

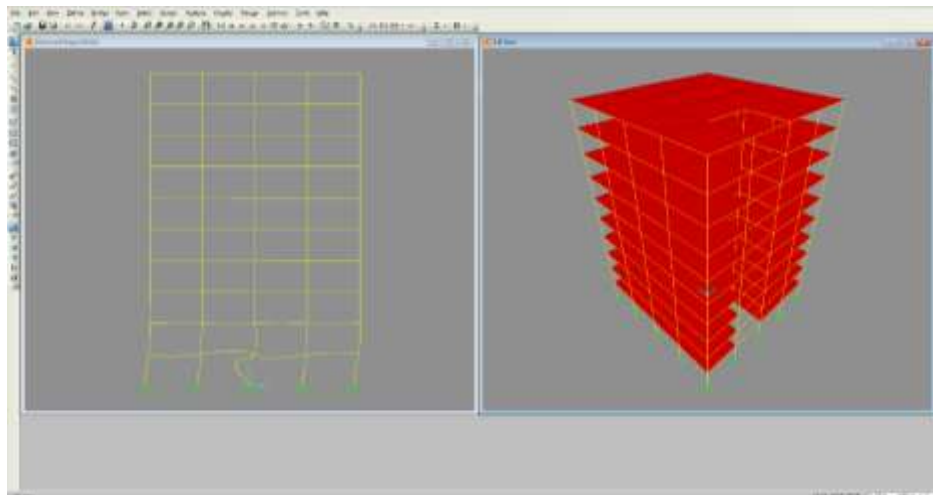
Fig. 12. Column damage in a 10-story structure.

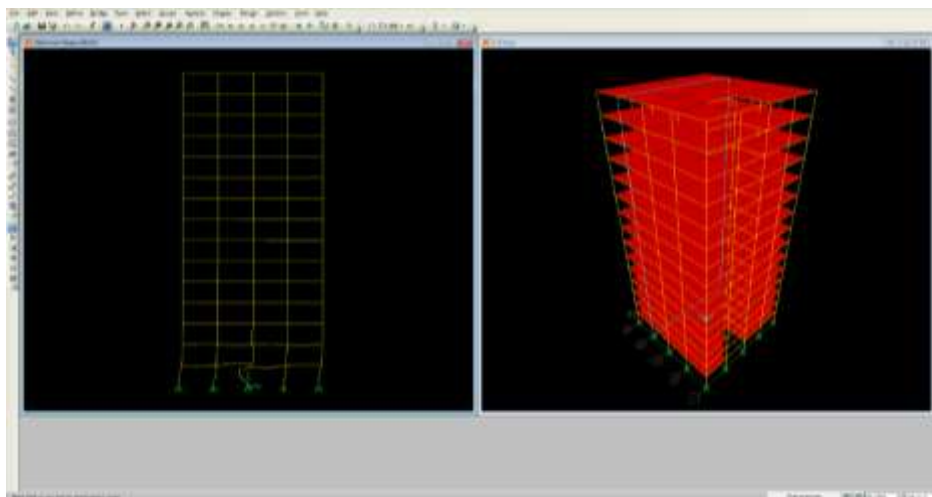
Fig. 13. Column failure in a 15-story structure.

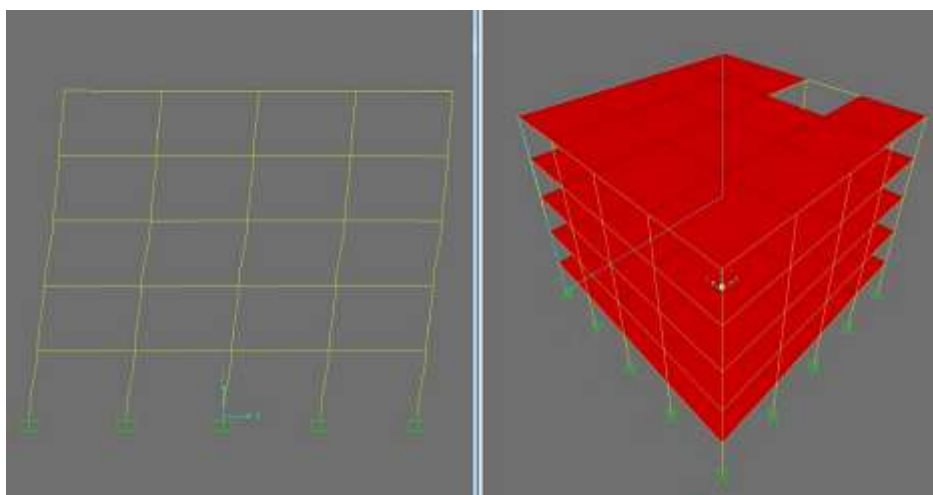
Fig. 14. The mechanism of forming plastic joints Model 1 in SAP software.

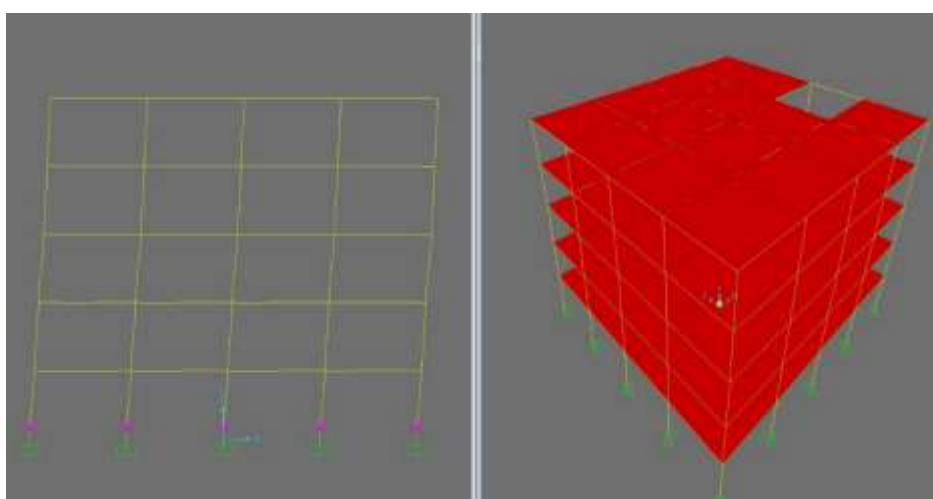
Fig. 15. The mechanism of forming plastic joints Model 1 in SAP software.

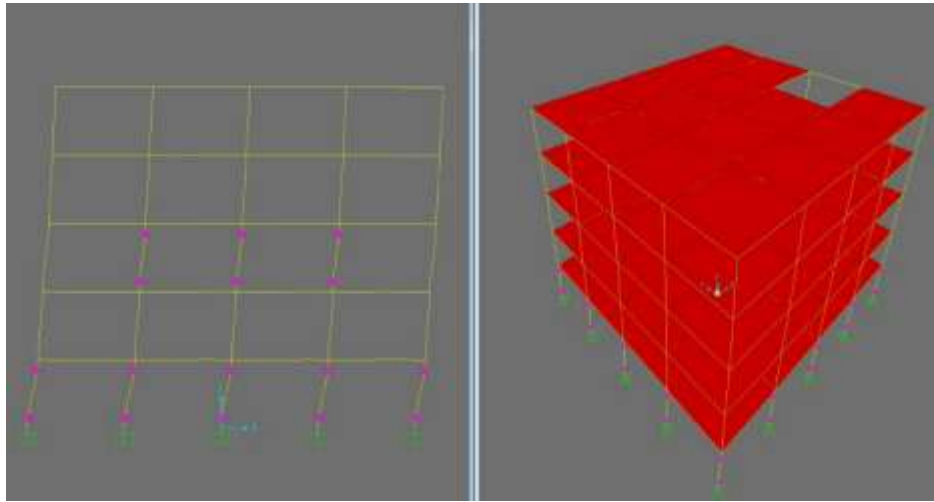
Fig. 16. Mechanism of forming plastic joints Model 1 in SAP software.
